THE CLEANING OF A CLASSIC (*Part One of Two*)

Article by F. Jack Eastman

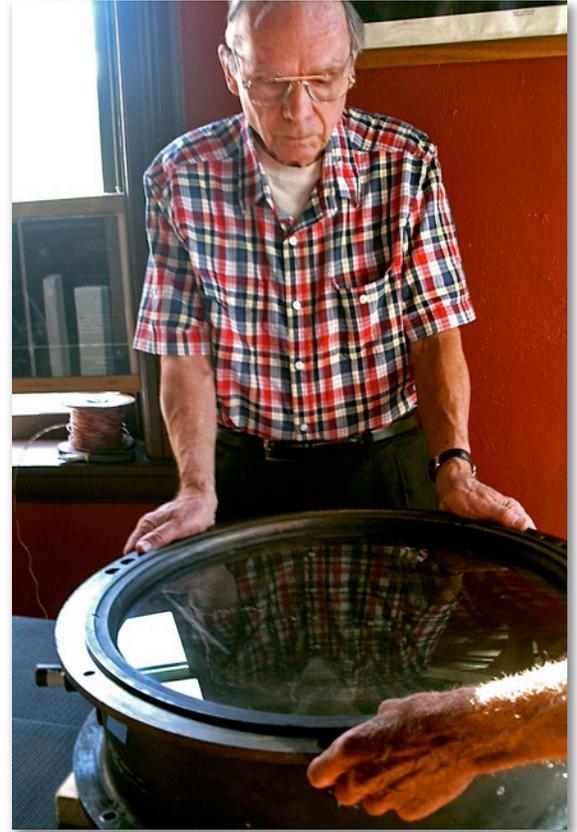
Chris Ray, from the Antique Telescope Society, examines the lens cell from the 20-inch Clark refractor at Chamberlin. Undertaking the cleaning of the elements proved less daunting than first thought, and Chris's knowledge and experience were invaluable in understanding the various components of the assembly and how best to restore it probably fell them.

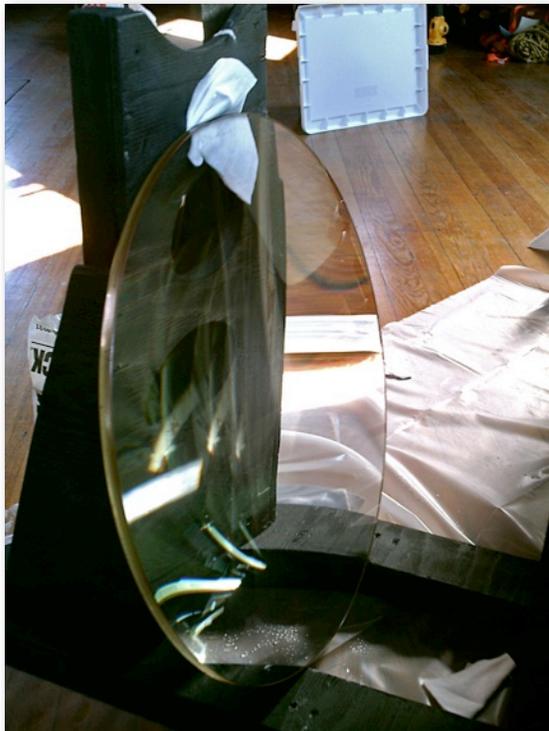
We measured the lens edge thicknesses, edge separation and lens glass diameter (21.38 inches [542.9 mm]), After cleaning and rinsing with purified distilled water, the crown lens rests on a special rack to air-dry. The cleaned elements revealed almost no flaws, save for some trapped air bubbles, a testament to the care given these pieces when they were crafted.

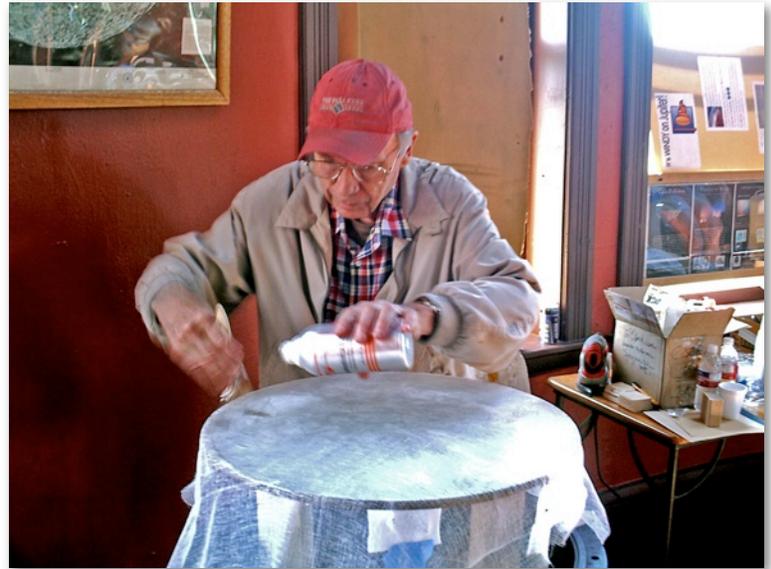
Chris applies a collodion preparation to the front surface of the crown element. This highly-flammable mixture of pyroxylin, ether and alcohol adheres to solid contaminants on the lens. Draping a layer of cheesecloth over the top and allowing the mixture to dry permits the debris to be removed safely, without scrubbing, by peeling the cloth slowly from the surface.

As the glass was removed, the positions of the lenses (clock angle) relative to the cell were marked with a waterproof marker, also indicating the direction the lens element was found so we wouldn't replace the lens backwards. The outer surface of the front element (the crown) was very dirty, so Chris decided to give it a collodion treatment. Collodion is gelatin dissolved in ether (note: gotta be used in a well-ventilated area!) Chris painted a layer of the stuff on the lens, placed a sheet of cheesecloth on it and applied a second coat. After several minutes this coating was peeled off, and all the crud on the glass came with it, a very effective trick for removing all the particulate matter otherwise stuck to the glass without any rubbing or other action which could damage the lens surface. The lens was then washed as before with the flint element. The cell was thoroughly cleaned and treated with "rust reverser," a chemical that turns rust into a harmless polymer and prevents any further damage and corrosion. Aaron determined the point on the cell that is at the bottom when the telescope is stowed and drilled a small "weep hole" just behind the silver edge support which would allow condensed
